SELF-HEALING CONCRETE IN AGGRESSIVE ENVIRONMENTS

Nele De Belie¹, Kim Van Tittelboom¹, Mathias Maes¹, Bjorn Van Belleghem^{1,2}, Philip Van den Heede^{1,2}

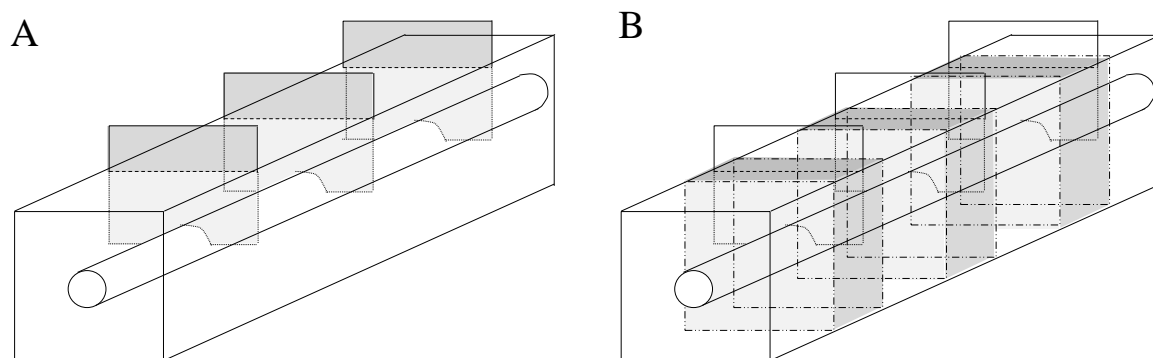
Figure 1. Preparation of the reinforced mortar samples used for the accelerated corrosion test.

Finally, to test the efficiency of (combinations of) WRA and CI, accelerated corrosion tests were performed on standard mortar prisms (sand:cement:water = 3:1:0.5; $40 \times 40 \times 160$ mm³). One smooth reinforcement bar with a diameter of 8 mm was placed centrally along the length of the molds (Figure 1). Artificial cracks were introduced by placing brass plates of 300 μm thickness in the mold up to the mid-level of the reinforcement bars. These plates had a width of around 40 mm and had a half sphere drilled out at the bottom with the same radius as the reinforcement bar for positioning onto the rebar (Figure 1.A). Samples were demoulded after 24 hours and the brass plates were removed at the same time. Finally, samples with a targeted thickness of 12 mm were sawn from the prismatic mortar specimens after the trowelled surface was smoothened (Figure 1.B). For the accelerated corrosion test, the edges of the samples were covered 10 mm high on the sides with aluminum butyl tape to ensure that only the cracked surface was exposed to the chloride solution. Furthermore, an electrical connection was made with the reinforcement bar by means of a copper wire. An overview of the different test series with their corresponding code is given in Table 1. The cracks were repaired by injecting the WRA and/or CI, which were not admixed (Table 1), into the crack by means of a syringe with a needle. For every specimen, a volume of 0.43 ml was injected.

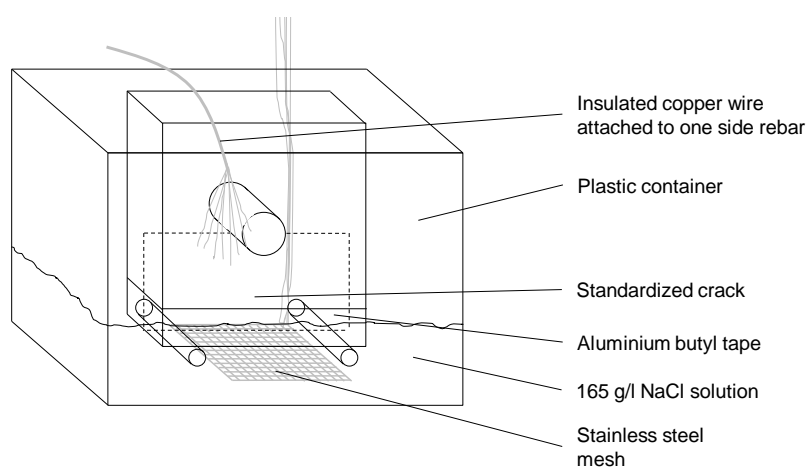
Figure 2. Test setup used for the accelerated corrosion test.

To evaluate the performance of the different WRA and CI in a short time-span, an accelerated corrosion test was performed. The mortar prisms were positioned inside a plastic box on two line supports with the crack facing downward and a stainless steel mesh in between the supports as shown in Figure 2. The mesh and the bottom of the specimen were submerged into a 165 g/l NaCl solution. The copper wire of the specimen and the stainless steel mesh were respectively connected to the positive and the negative terminal of a power supply. An electric potential of 12 V was imposed between the rebar and the mesh. The imposed voltage on the reinforcement steel increased the velocity of chloride ion movement in the sample, hence accelerating the corrosion process together with the higher concentration of NaCl solution. During the test, every 1.5 hours the current was monitored and a visual observation of all specimens was performed.

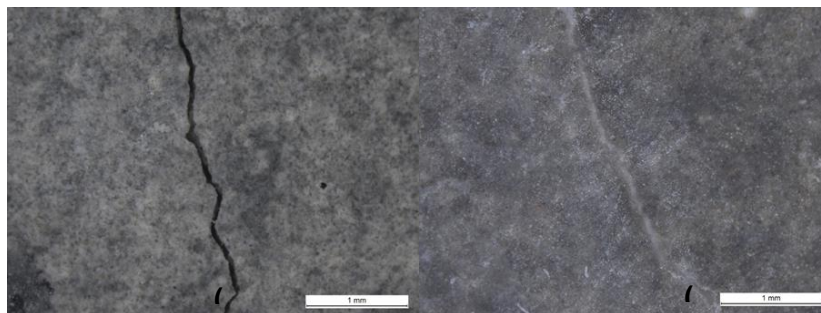
Figure 3: Crack with initial width of $\sim 100\ \mu\text{m}$ in OPC mortar before (left) and after (right) 196 days immersion in 165 g/l NaCl + 42.5 g/l MgSO_4 [1]

As explained more in detail in [1], autogenous crack healing occurs quite fast by means of calcium carbonate precipitation and ongoing hydration when mortar is cyclically exposed to wet/dry conditions. In case of continuous immersion, autogenous crack healing occurs much slower and mainly by means of ongoing hydration. The composition of the environmental solution, with or without chlorides, has no significant influence on the healing mechanism. However, the presence of magnesium sulphate results in the formation of a brucite layer, sealing the cracks (Figure 3). Crack widths lower than $105\ \mu\text{m}$ are able to heal autogenously. Crack widths larger than $105\ \mu\text{m}$ will also heal but not completely. As a result, crack healing in these larger cracks will not much improve the resistance against the penetration of aggressive substance such as chlorides.

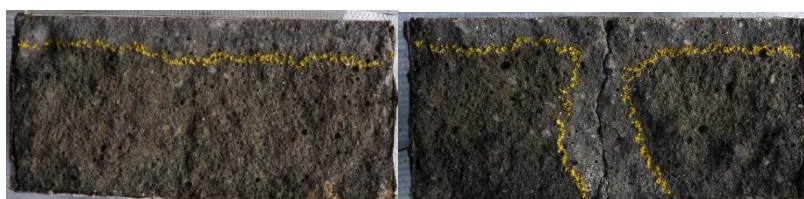
Figure 2: Chloride penetration in autogenously healed mortar with a remaining crack width $< 10\ \mu\text{m}$ (left) and $> 10\ \mu\text{m}$ (right) [adapted from 1]

It appears that $10\ \mu\text{m}$ is the critical crack width for chloride penetration, and at lower crack widths the mortar behaves as being uncracked (Figure 4).

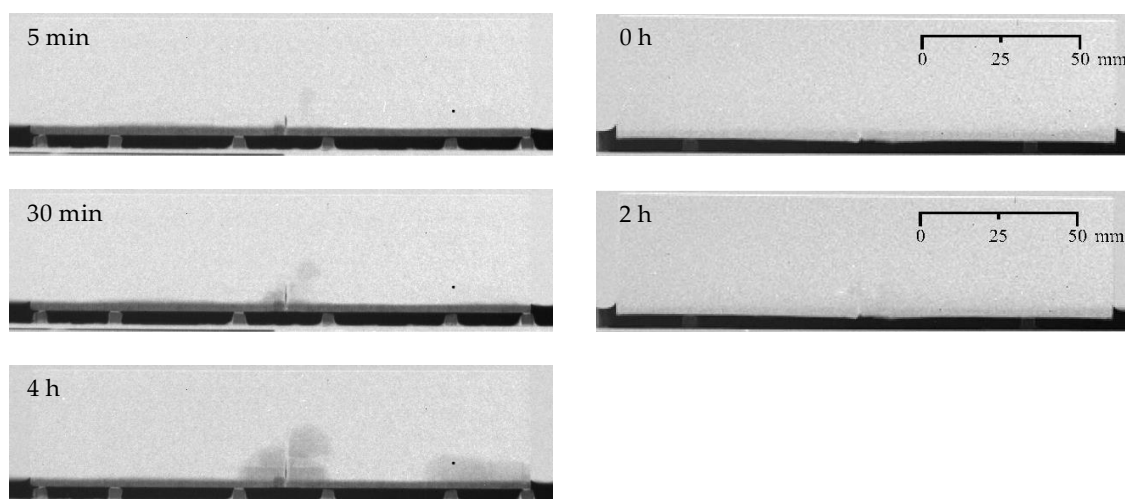
Figure 5. Water uptake in cracked mortar as a function of exposure time using neutron radiography: (left) crack healing before contact with water; (right) immediate contact with water after crack formation (adapted from [6])

In the previous experiments, the healing agents were allowed to harden 24 h before bringing them in contact with water. However, in real structures, contact with water may occur immediately after crack formation. This effect was investigated in [6] by taking neutron radiography images of specimens where exposure to water started immediately after formation of the standardized crack through removal of the thin metal plates which triggered the release of the healing agent. In contrast with the specimens where the polyurethane in cracks had already hardened (Figure 5, left), these specimens (Figure 5, right) show an enhanced healing efficiency. It appears that the immediate contact of the moisture-curing polyurethane with water creates the optimal conditions for its reaction.

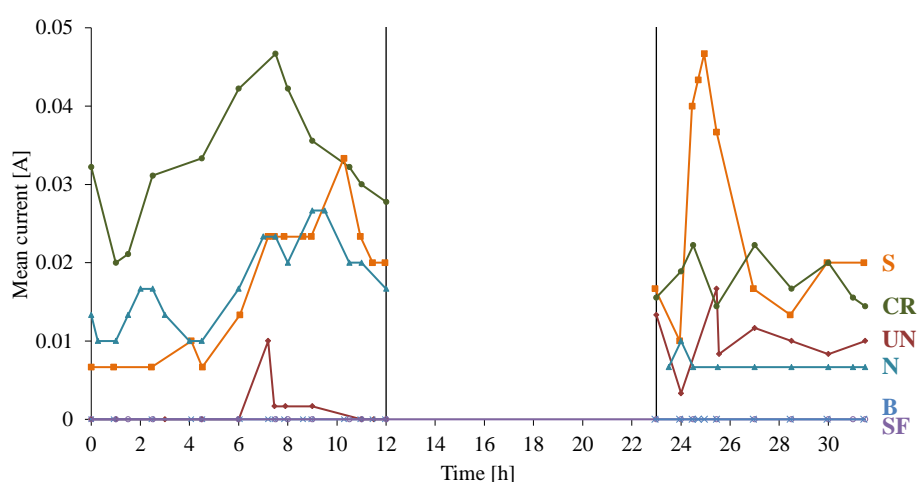
Figure 6. Evolution of the mean current over time for the different test series.

Regarding the accelerated corrosion tests on mortars with WRA and/or **CI**, the current evolution was measured and the status of the rebar and surrounding mortar matrix was observed from the side of the samples. The current was recorded every 1.5 hours for a total of 31.5 hours. The mean current measured for all samples of each test series is plotted in Figure 6. Between 12 hours and 23 hours no current was measured due to the manual recording of these data points. If a current with a value of zero was recorded, it is assumed that no corrosion took place. Higher values indicated a higher probability of the corrosion reaction occurring. Comparing series UN and CR in Figure 6, shows that obviously higher current values were obtained for the latter. The evolution shows the increase to a peak, after which the current decreases again which can be explained by the hindering of transport of chlorides to the reinforcement due to the formed corrosion products which are acting as a barrier and due to the formation of horizontal cracks in the mortar matrix. The small peak noticed for the UN series around 7 hours was caused by one sample starting to show an unexpected behavior (see further), which later on stabilized again. The measured currents for the samples with admixed or injected WRA and/or **CI** are constrained by the cracked reference samples as an upper boundary, except for the second measuring period where series S resulted in the highest current with a peak around 25 hours. Samples treated with sodium nitrite (series N) showed a steady increase of the current at first after which a small decrease occurred, leading to a stable rate. For the SF series no current was measured during the entire test. Based on this accelerated corrosion test, one can conclude that the combination of Sikagard 705 L and Ferrogard 901 S (series SF) seems very promising to efficiently halt the corrosion initiation.

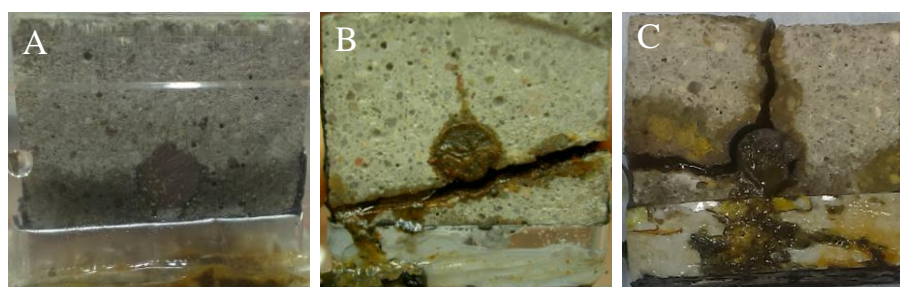
Figure 7. Observed stages within the corrosion process: A. Moist matrix up to the reinforcement level; B. Horizontal crack formation in the mortar matrix; C. Vertical crack formation in the mortar matrix.

Together with the current recordings, pictures were taken of the specimens every 1.5 hours in order to monitor visual changes on a regular base. Figure 7 shows the different stages of deterioration which were noticed. The first stage corresponded to the point where the moisture front, caused by NaCl ingress through the artificial crack, reached the reinforcement level. The second

stage corresponded to the point at which the corrosion process had started, resulting in tensile stress formation and leading to a horizontal crack through the mortar at the reinforcement level. The last stage was represented by the formation of a vertical crack above the reinforcement bar.

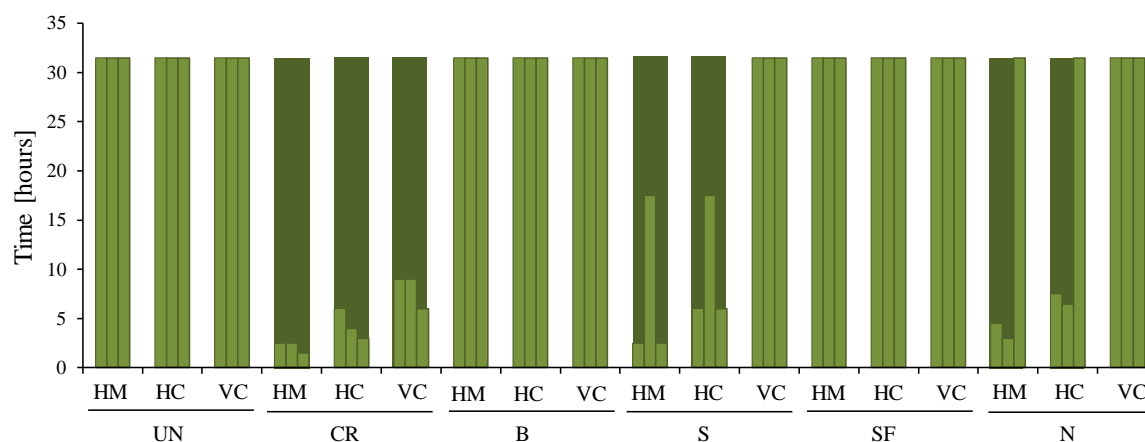
Figure 8. Time of appearance of the different degradation stages for the samples of all test series (light green colour indicates that the degradation stage was not yet noticed; as soon as a certain degradation mechanism was noticed, the colour changes to dark green, HM = horizontal moisture front, HC = horizontal crack and VC = vertical crack).

In Figure 8 the time at which one of the three above mentioned stages was observed is shown. In agreement with the outcome of the current evolution, samples of the UN, B and SF series performed very well and exhibited none of the three aforementioned stages. After completion of the test, it appeared that for one sample of the UN series a small transverse crack at the bottom surface was present in one of the samples. This was probably present from the start which could explain the higher current measured at 7 hours compared to the other samples of this series. In general, the samples of the CR series showed a faster evolution in deterioration compared to the less performing treated samples. In less than 10 hours of exposure to the accelerated corrosion test all samples of the CR series showed moisture ingress, followed by horizontal and vertical crack formation in the mortar matrix due to formation of expansive corrosion products. Also for the samples of the S and the N series, moisture ingress and horizontal crack formation was noticed. However, it seemed that due to the treatment the damage due to corrosion was less severe compared to the series with untreated cracks (CR) and vertical cracking could be prevented. Moreover, for the series treated with sodium nitrite only two out of the three samples showed some degradation.
